***Russia's Ka-52 Attack Helicopters Have A Serious Vibration Problem***  
***Thomas Newdick - The Drive***

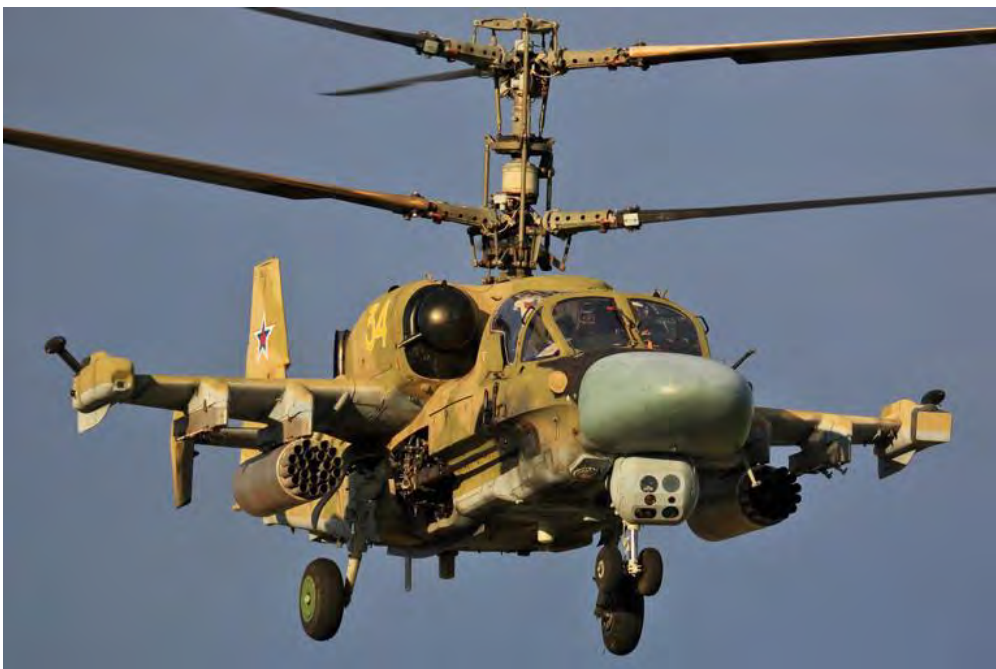
*The two-seat Ka-52 is an attack helicopter with an unconventional coaxial main rotor arrangement, obviating the need for a tail rotor. It’s fitted with a two-spar stub wing on each side of the fuselage. These ‘wings’ have no high-lift devices; they serve exclusively to carry armament and other stores, as well as sensors and flare dispensers at the tips.*

*A Russian Aerospace Forces Ka-52, here relatively lightly laden, with just a pair of rocket pods. Fedor Leukhin/Wikimedia Commons.*

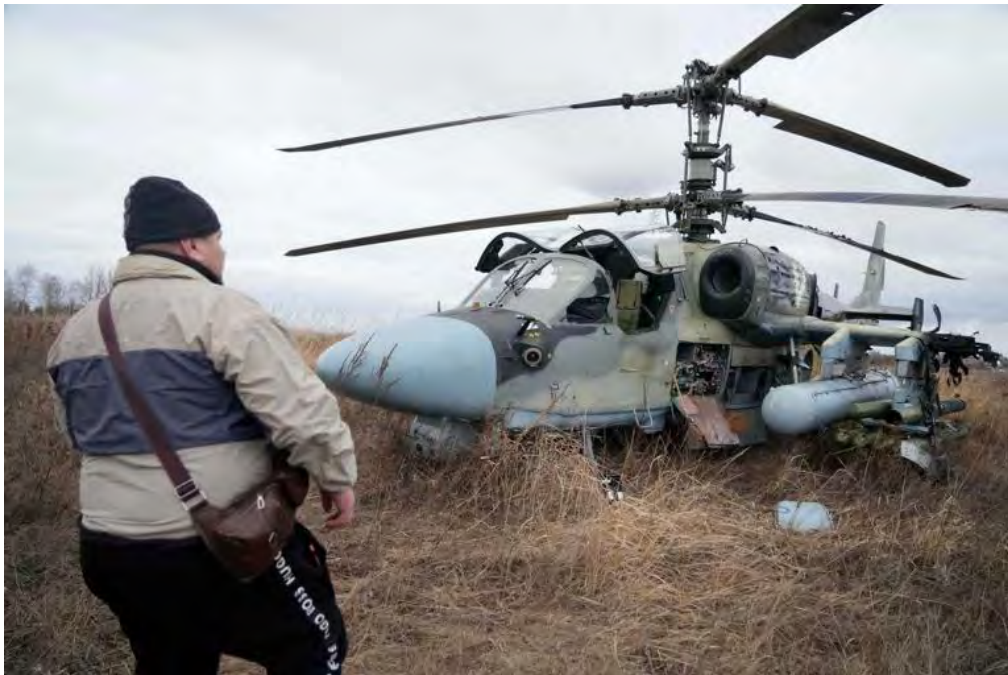
*Heavily armed Ka-52 helicopter with Igla-V MANPADS, Vikhr-1 and Ataka ATGM, and B-8V-20 rocket pods for 80mm S-8 rockets. Photo: Дмитрий Мецераков*

*In each case, the stub wings are fitted with heavy loads combining fuel tanks, [anti-tank guided missiles](#) (ATGMs), anti-aircraft missiles, and pods for [unguided rockets](#). In fact, videos showing such heavily laden Ka-52s are hard to find before the war in Ukraine, suggesting overall stores weight may play a role here.*
